YOUR ONESURVEY HOME REPORT

8 The Causer Nethybridge PH25 3DS

SINGLE SURVEY

Single Survey

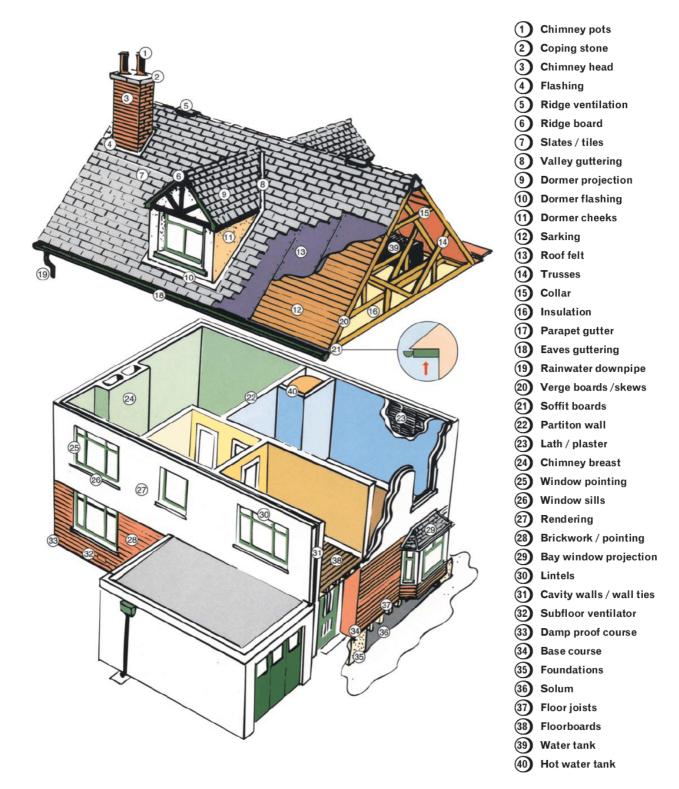
Sectional Diagram showing elements of a typical house

Reference may be made in this report to some or all of the above component parts of the property. This diagram may assist you in locating and understanding these items.
