YOUR ONESURVEY  
**HOME REPORT**

Oak Cottage  
Aviemore  
PH22 1PZ

# SINGLE SURVEY

# Single Survey

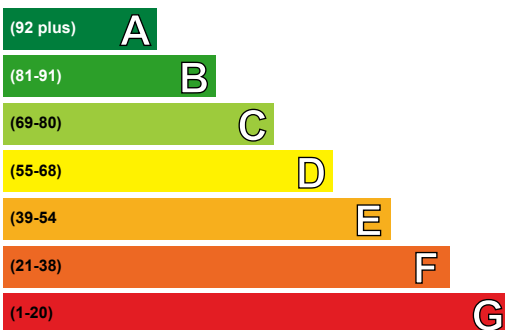
Very energy efficient - lower running costs

Not energy efficient - higher running costs

Current	Potential
75	85
