YOUR ONESURVEY
HOME REPORT

The Four Seasons
86A High Street
Grantown on Spey
PH26 3EL

SINGLE SURVEY

Single Survey

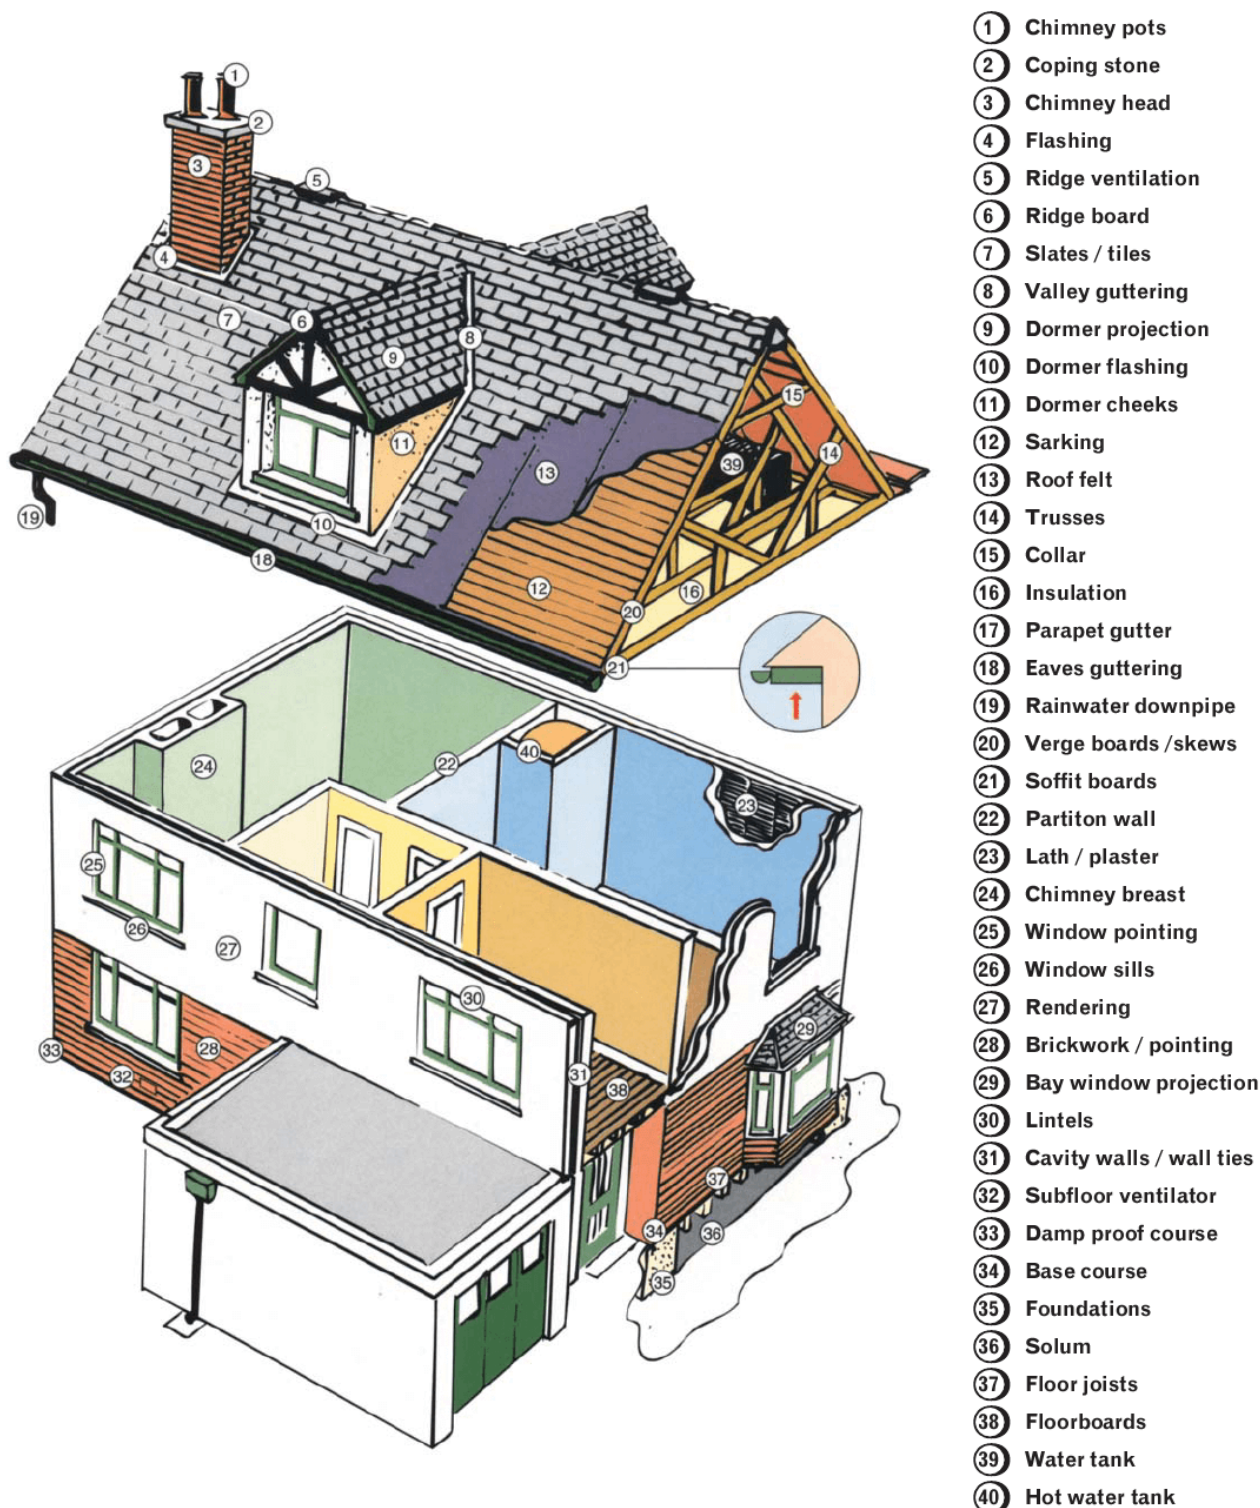
Sectional Diagram showing elements of a typical house

- ① Chimney pots
- ② Coping stone
- ③ Chimney head
- ④ Flashing
- ⑤ Ridge ventilation
- ⑥ Ridge board
- ⑦ Slates / tiles
- ⑧ Valley guttering
- ⑨ Dormer projection
- ⑩ Dormer flashing
- ⑪ Dormer cheeks
- ⑫ Sarking
- ⑬ Roof felt
- ⑭ Trusses
- ⑮ Collar
- ⑯ Insulation
- ⑰ Parapet gutter
- ⑱ Eaves guttering
- ⑲ Rainwater downpipe
- ⑳ Verge boards /skews
- ㉑ Soffit boards
- ㉒ Partiton wall
- ㉓ Lath / plaster
- ㉔ Chimney breast
- ㉕ Window pointing
- ㉖ Window sills
- ㉗ Rendering
- ㉘ Brickwork / pointing
- ㉙ Bay window projection
- ㉚ Lintels
- ㉛ Cavity walls / wall ties
- ㉜ Subfloor ventilator
- ㉝ Damp proof course
- ㉞ Base course
- ㉟ Foundations
- ㊱ Solum
- ㊲ Floor joists
- ㊳ Floorboards
- ㊴ Water tank
- ㊵ Hot water tank

Reference may be made in this report to some or all of the above component parts of the property. This diagram may assist you in locating and understanding these items.
