HOME REPORT

WESTWOOD INVERDRUIE

AVIEMORE
PH22 1QH

Single Survey

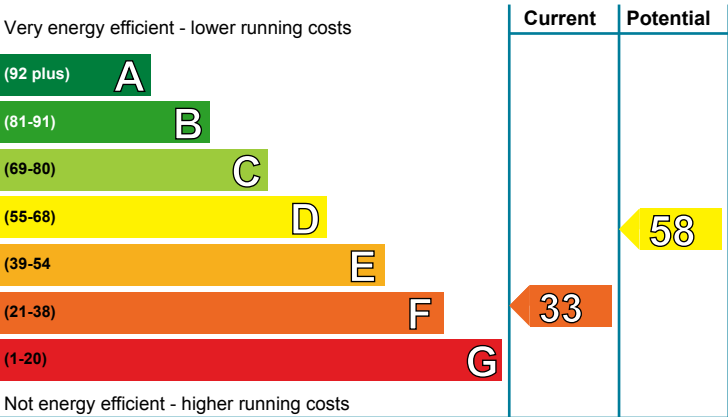
Energy Efficiency Rating

This graph shows the current efficiency of your home, taking into account both energy efficiency and fuel costs. The higher this rating, the lower your fuel bills are likely to be.

Your current rating is **band F (33)**. The average rating for EPCs in Scotland is **band D (61)**.

The potential rating shows the effect of undertaking all of the improvement measures listed within your recommendations report.

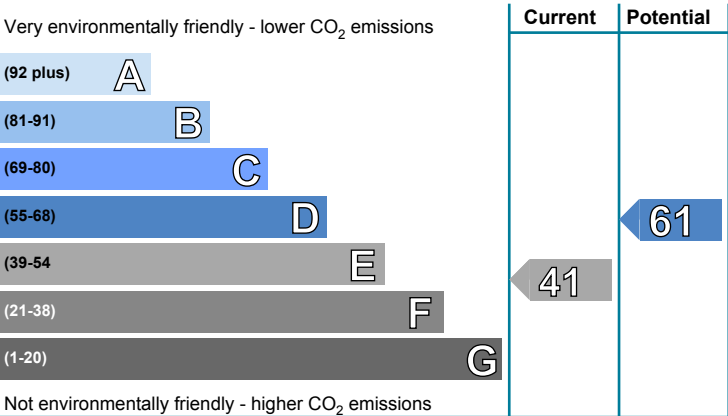
Environmental Impact (CO₂) Rating

This graph shows the effect of your home on the environment in terms of carbon dioxide (CO₂) emissions. The higher the rating, the less impact it has on the environment.

Your current rating is **band E (41)**. The average rating for EPCs in Scotland is **band D (59)**.

The potential rating shows the effect of undertaking all of the improvement measures listed within your recommendations report.
